Onsite Wastewater Maintenance Company

A Follow-Up Maintenance Report

Re: Maintenance of the Onsite Sewage Treatment System
serving the home at 2579 Example Rd., Islandtown, B.C.

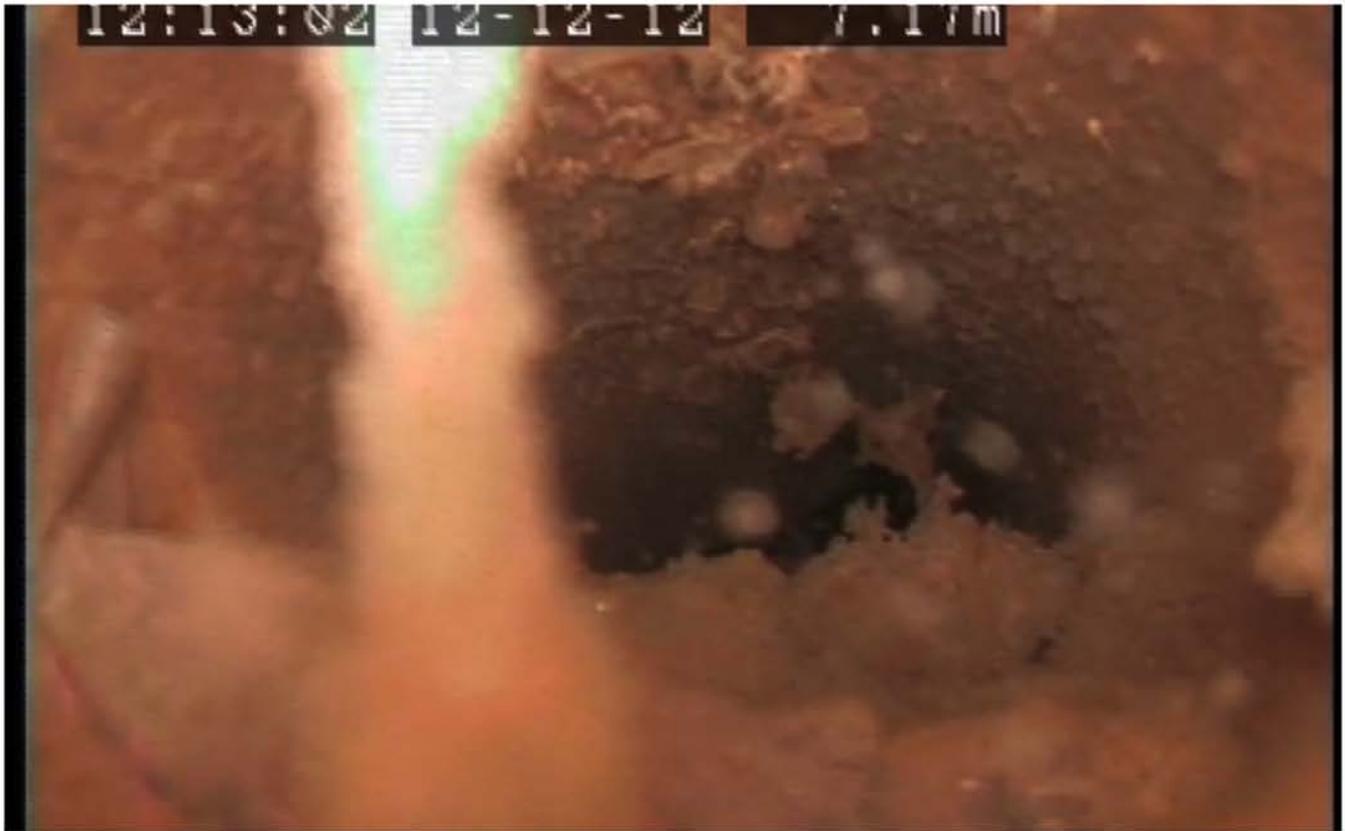
During the Initial Maintenance Assessment carried out on (date), it was discovered that the septic tank was ready for pumping, the pump chamber contained sludge material that needed to be cleaned out, and the pipes of the dispersal field also needed to be cleaned. I attended this site today to observe the cleaning of the tank and pump chamber, and to use my equipment to clean out the dispersal pipes.

Example of the Typical Interior Conditions of the Pipes Before Cleaning

I used a combination of a water jetting tool and a vacuum hose to scour the interior of the pipes and remove the slurry of water and debris. I sent the pipe camera down each run and was able to confirm that the cleaning was very effective. A before and after photograph of the typical pipe interior is attached to this report.

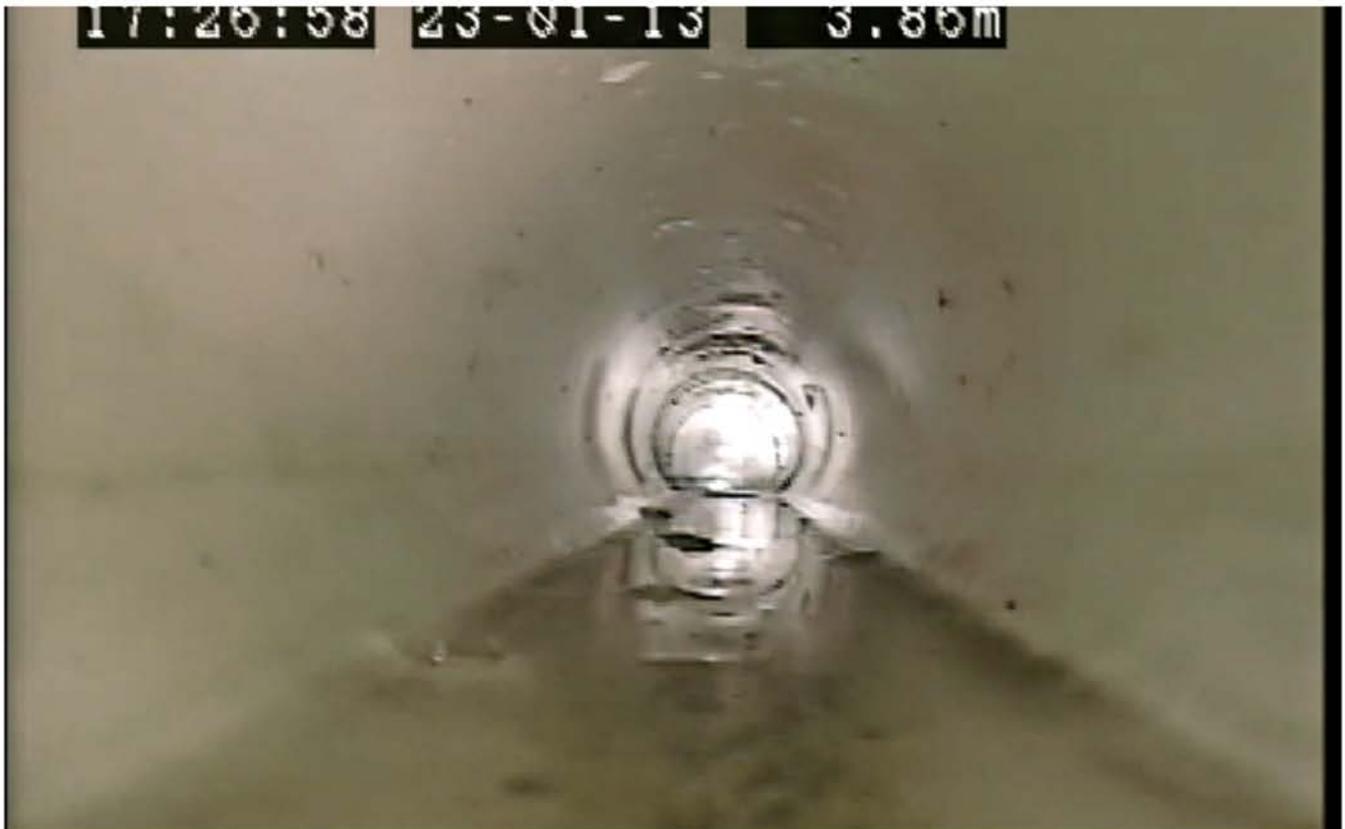
Example of the Typical Interior Conditions of the Pipes After Cleaning
