# Onsite Wastewater Maintenance Company

## A Maintenance Report

Re: Maintenance of the Onsite Sewage Treatment System  
serving the home at 2579 Example Rd., Islandtown, B.C.

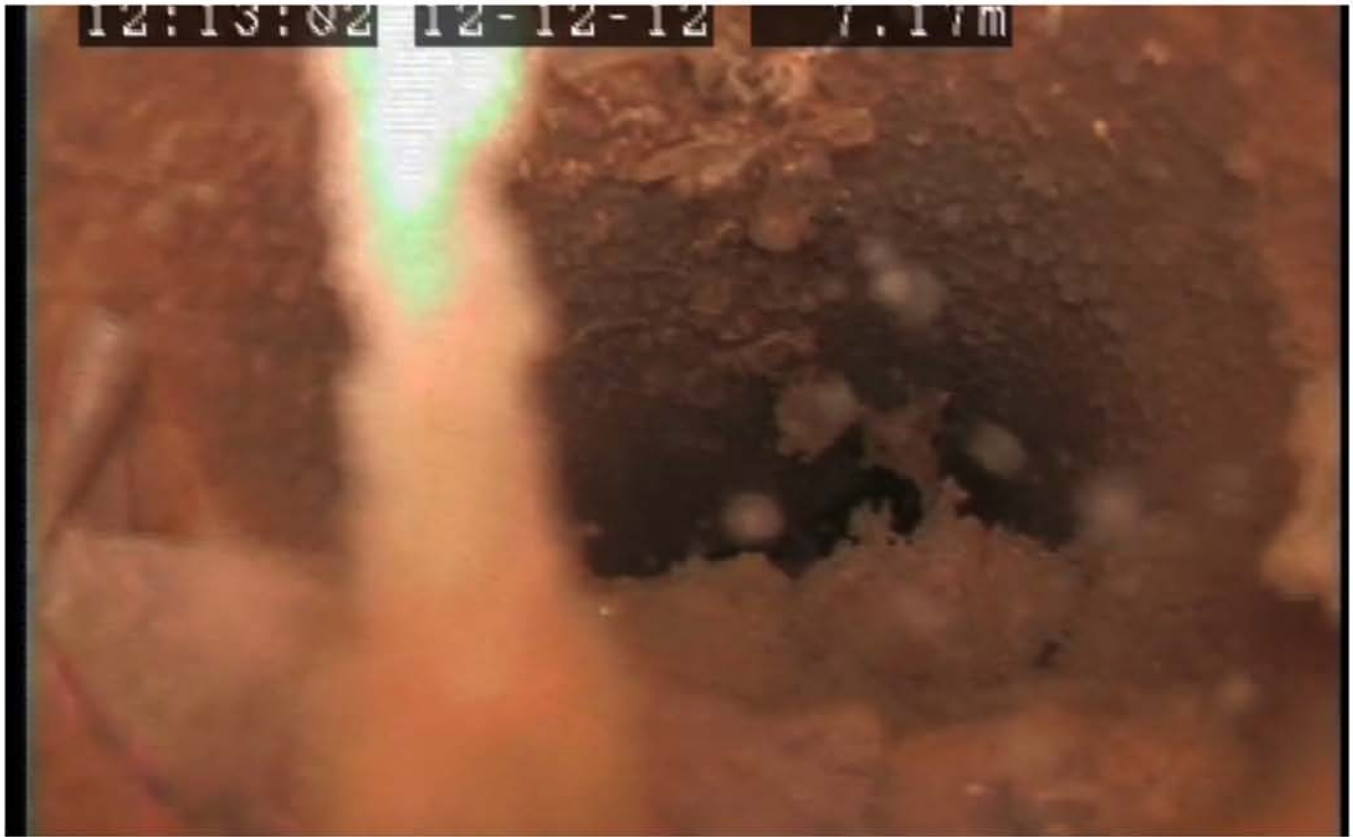
I attended the above-noted site today at your request, as the result of an inspection carried out by a Registered Onsite Wastewater Practitioner – Private Inspector on behalf of a prospective buyer of the property. As was explained to me, the Private Inspector had identified that the pipes within the dispersal field were clogged with what appeared to be soil and sludge, causing the fluid level to back-up when the pump turned on. I contacted the Private Inspector for further information, and their client did agree to release a copy of the report to me to ensure that the most appropriate work could be done.

Example of the Typical Interior Conditions of the Pipes Before Cleaning

I used a combination of a water jetting tool and a vacuum hose to clear the interior of the pipes in the dispersal field and remove the slurry of water and debris. I sent the pipe camera down each run and was able to confirm that the cleaning was generally effective. A before and after photograph of the typical pipe interior is attached to this report.

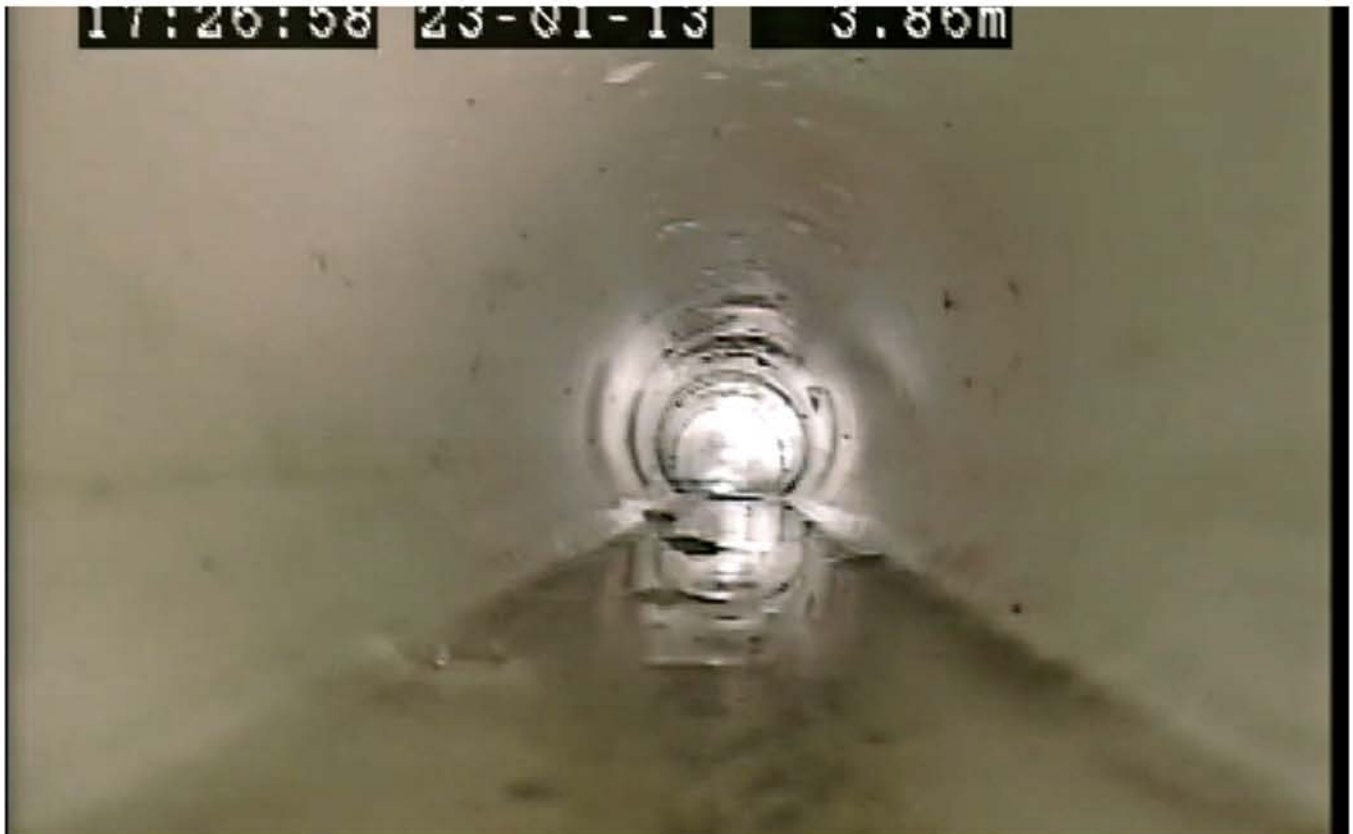
Example of the Typical Interior Conditions of the Pipes After Cleaning
